## • Methuen, MA

- Off East Capitol Street and Marc Ave, two ditches were restored to their original dimensions after being completely overgrown by *Phragmites australis*, an invasive common reed.
- NEMMC mowed the invasive species so that the remains of the existing ditch could be found.
- Excavation of the invasive vegetation allowed water to flow into a nearby larger ditch.

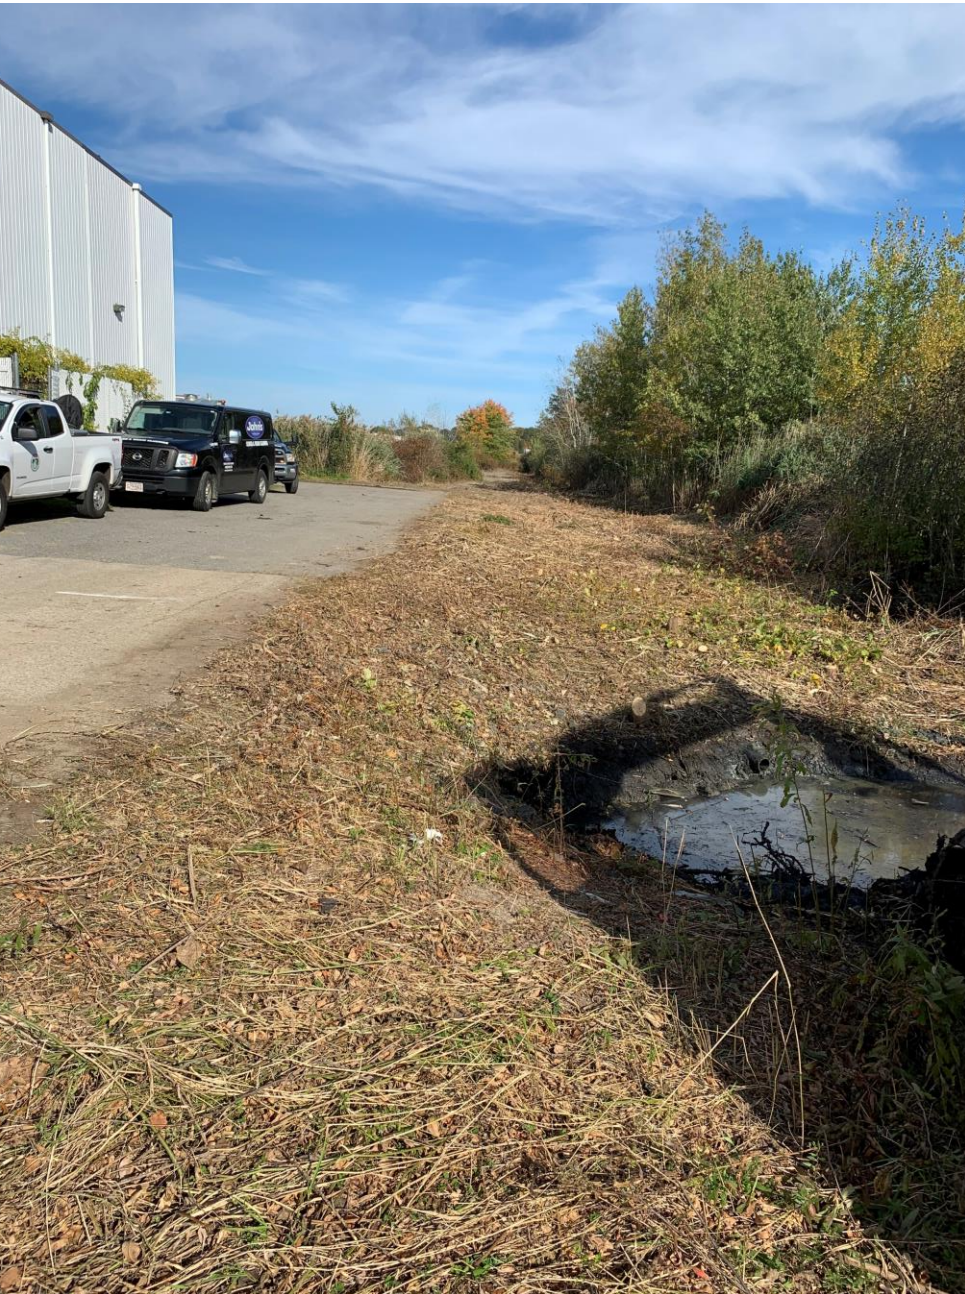
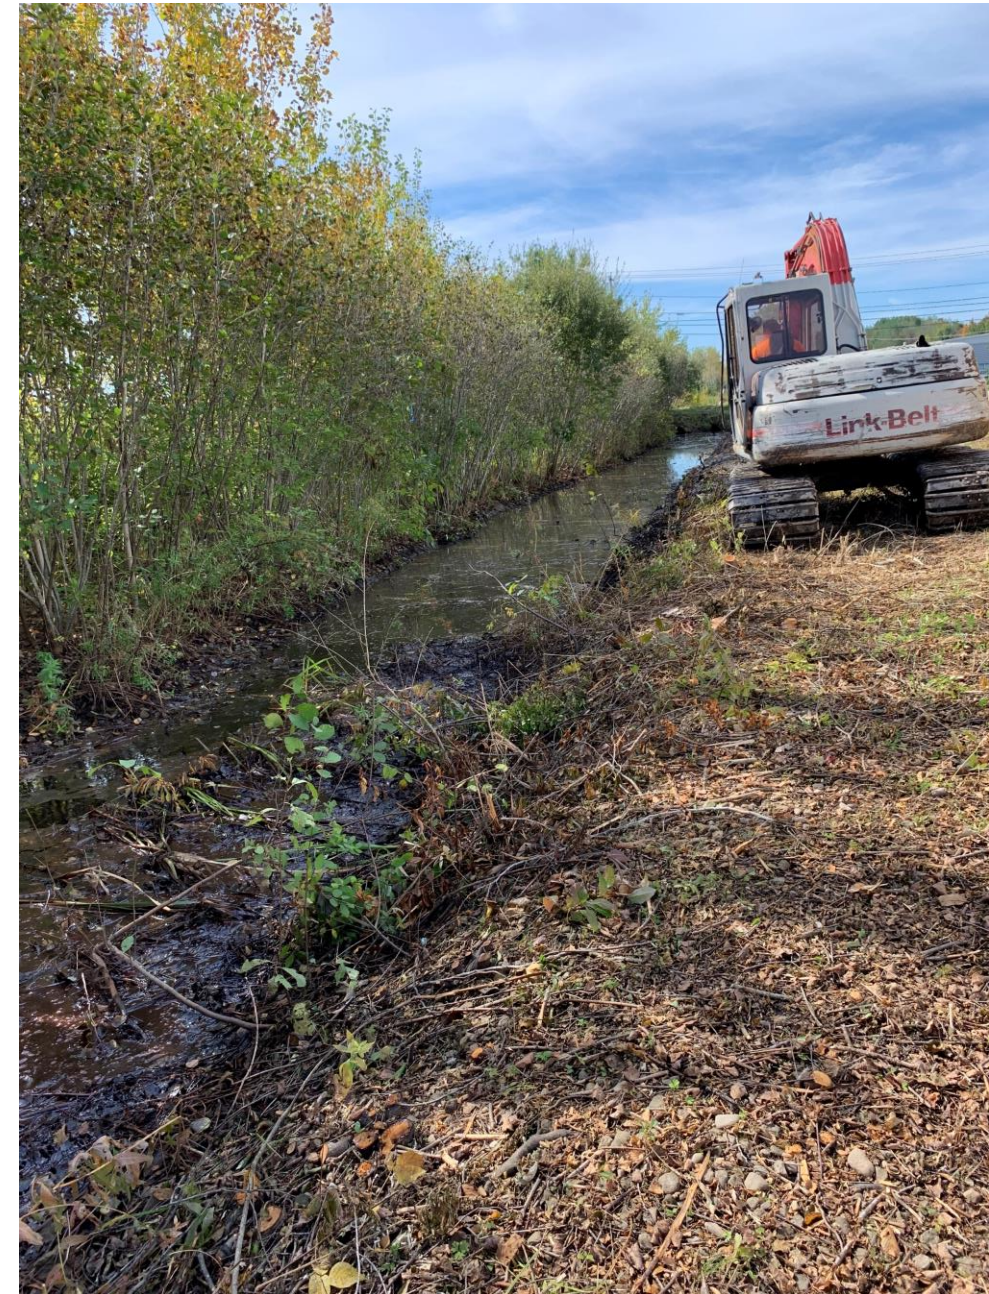
- Newburyport, MA (1/2)

- From Opportunity Way to Malcolm Hoyt Drive invasive species overgrowth choked a ditch which was causing major flooding to nearby businesses.
- After mowing, only a small stream was visible. NEMMC excavated the ditch to it's original dimensions to accommodate water during heavy rainfall.
- The town disposed of the spoil and jetted the culverts allowing for water to move to Little River.

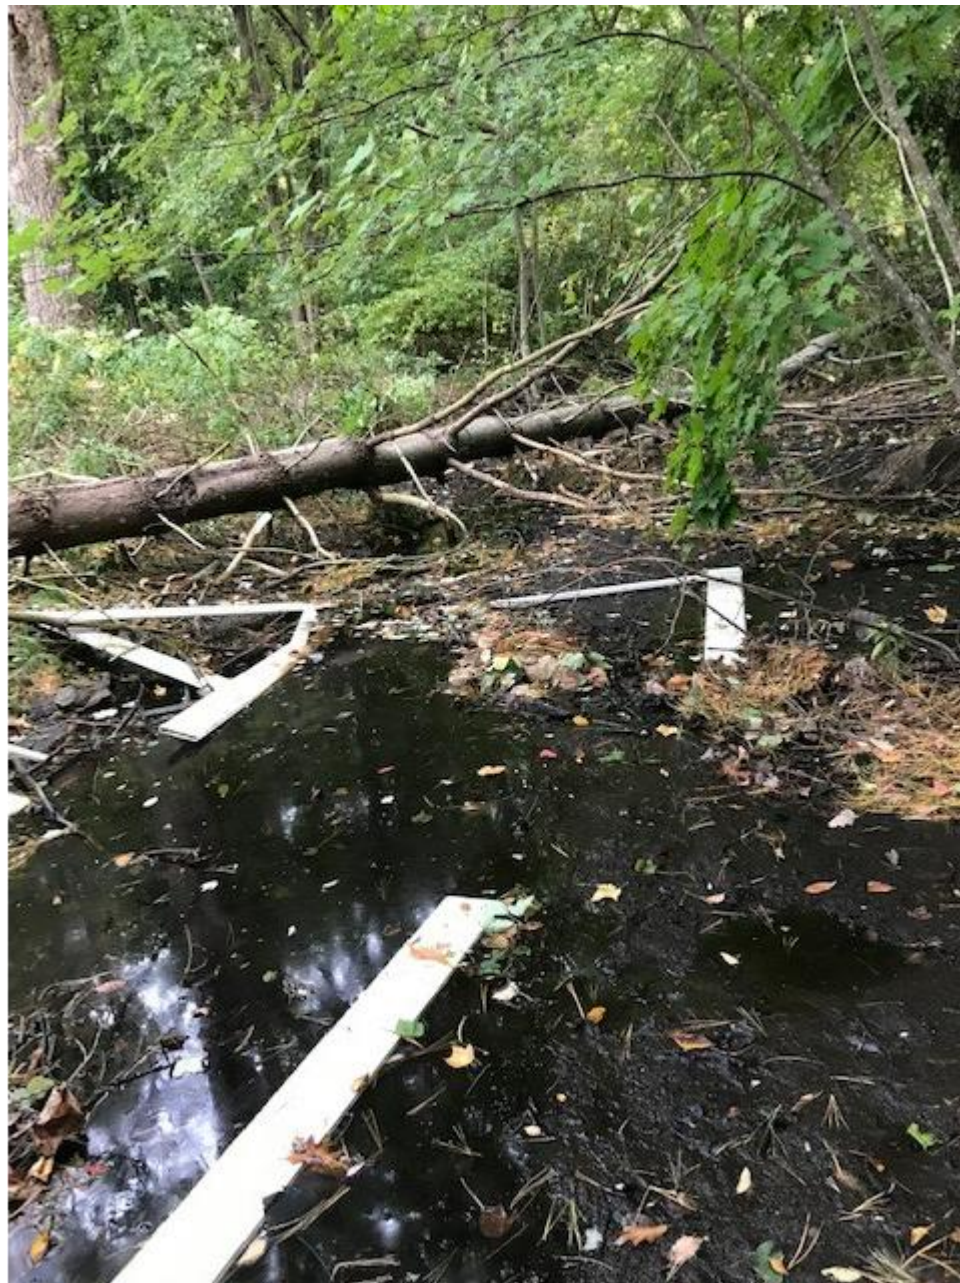
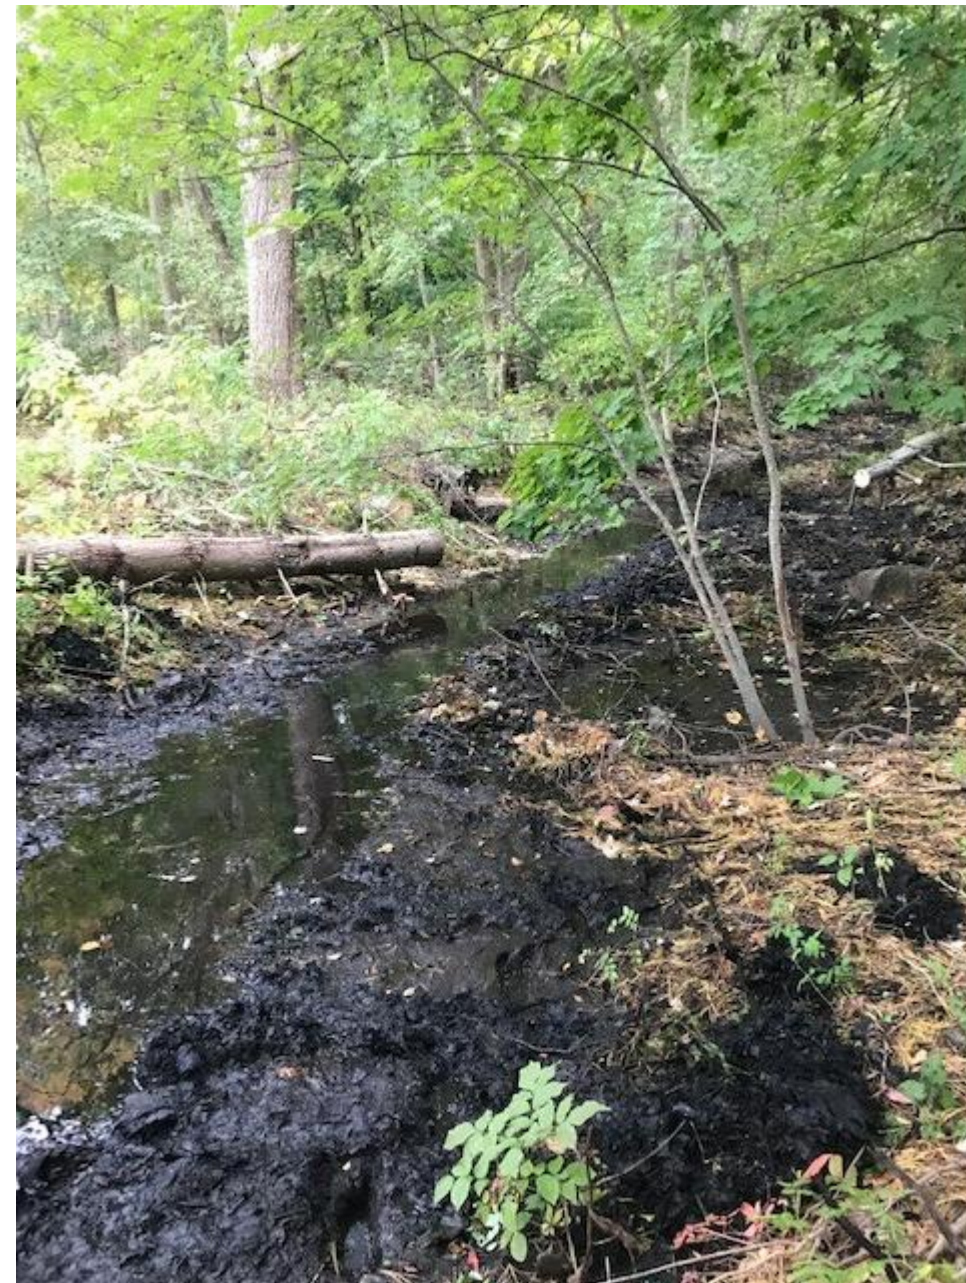
- Lynnfield, MA

- Hand ditch maintenance (HDM) was completed along Hawkes Brook between the culverts of Fletcher Road and Timberhill Lane.
- HDM is when the crew removes stream impediments that are blocking the flow of water within an established ditch. Small hand tools such as rakes, and chainsaws are used.
- These blockages can lead to flooding and pools of water where mosquitoes can breed.

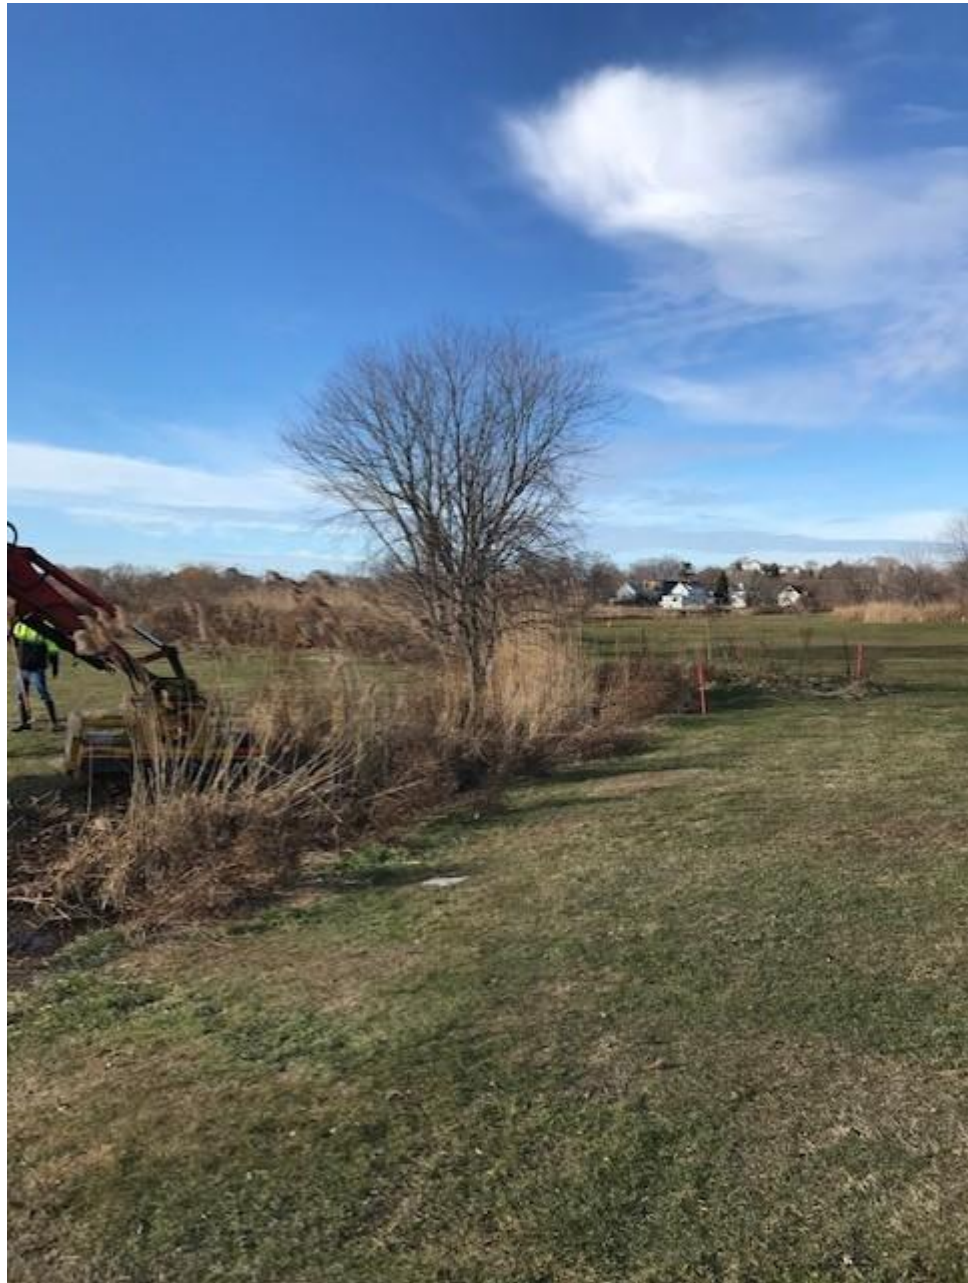
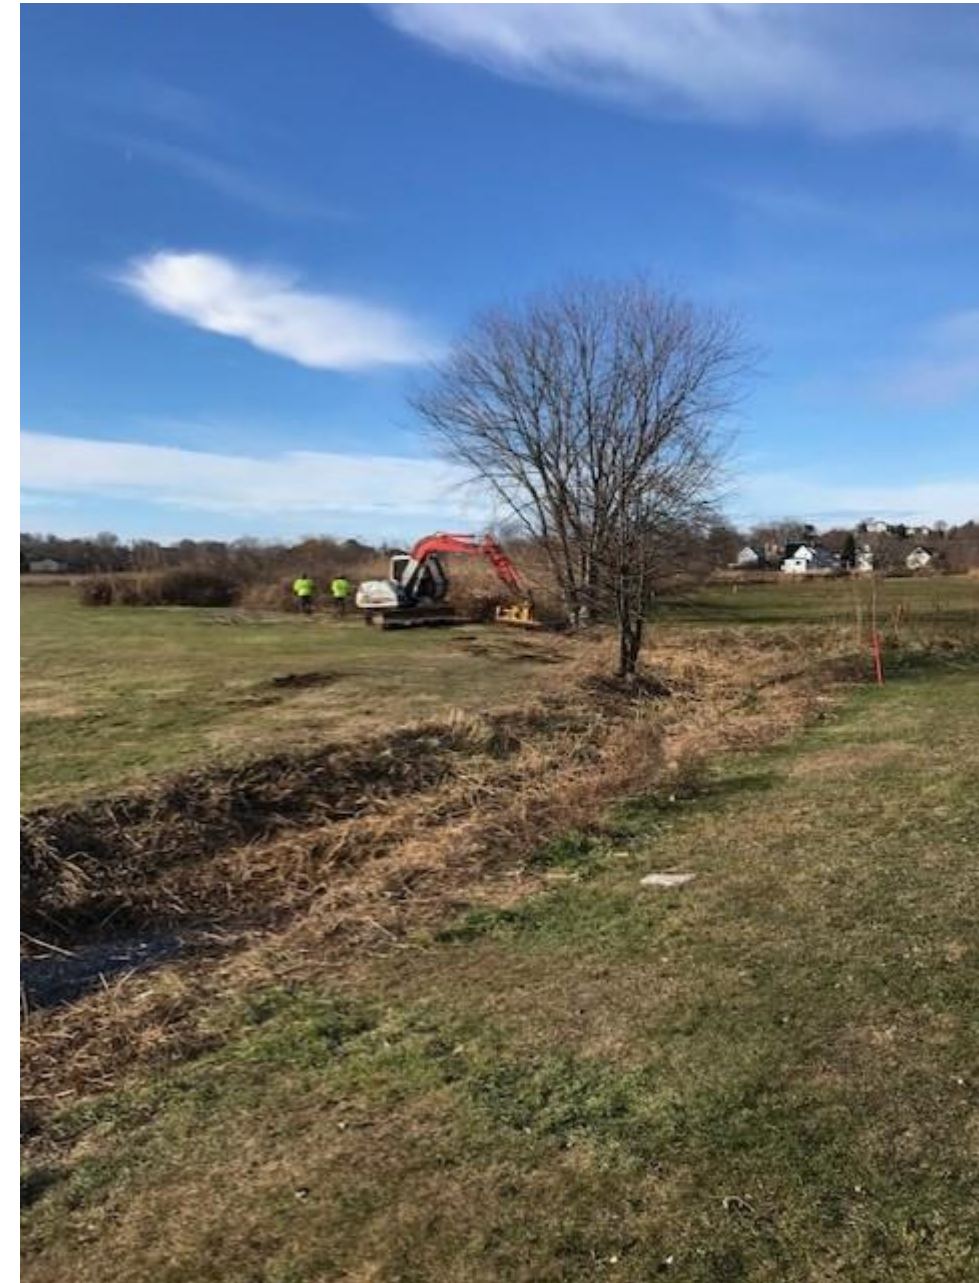
- Nahant, MA

- From White Way to Flash Road, *Phragmites australis* and other vegetation grew over the ditch that ran through this town owned land.
- NEMMC mowed and excavated the overgrown vegetation as to allow the water to flow as it did when it was first excavated.

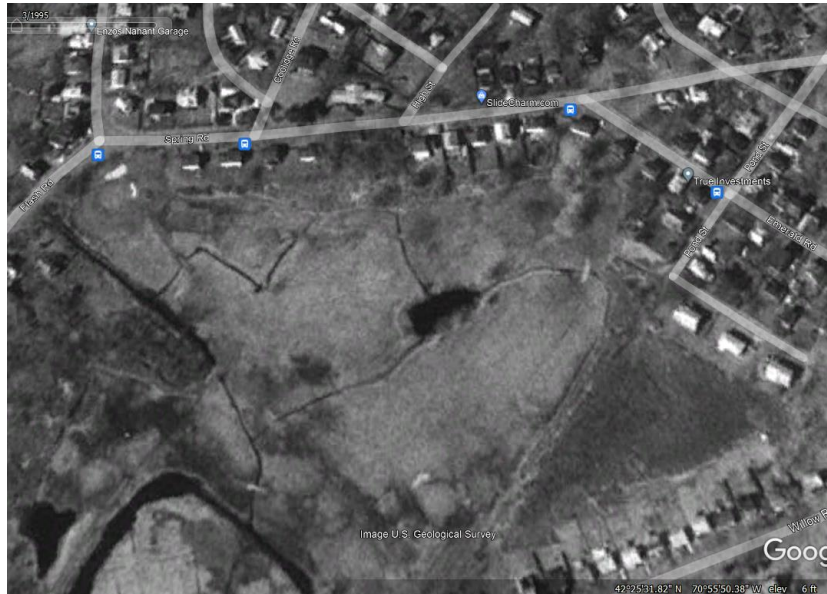
1995

- Over the years, you can see from satellite imagery that the vegetation has slowly grown over the ditch.
